TEST REPORT

No.: 094172

Investigations with anchoring of roping devices

Object of testing: Project St. George Wharf: "Eyebolts"

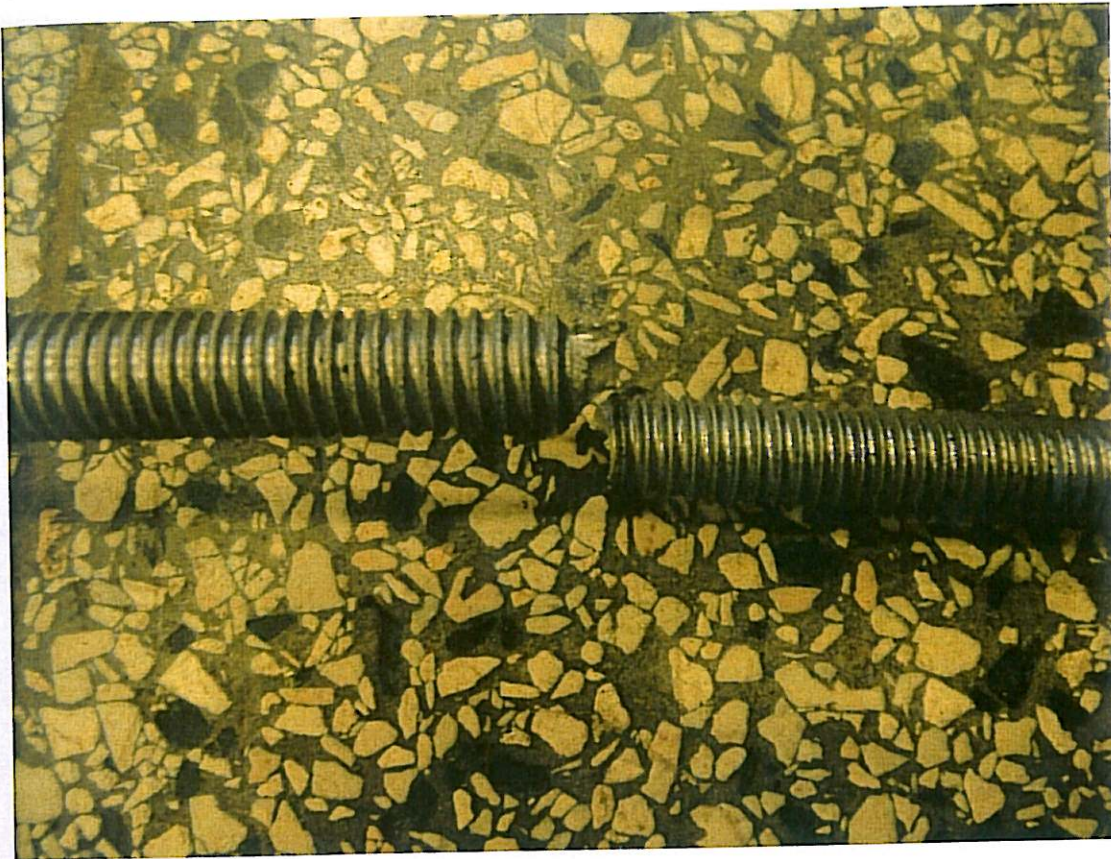
Tests were starting with the type 2 application. Failure at the load introduction point at the top of the test set-up occurred in test No. 1, therefore the load introduction point of all the set-ups was strengthened. Then the tests were continued with two tests with the type 2 application and two tests with the type 1 application. Performance of a third test with type 1 (Test No. 6) was not possible due to deformation at the upper flange of the hollow-section. Failure in tests No. 2 to 5 occurred by breaking in the threads of the Eyebolts. Table 1 lists the test results.

Fig. 5: Failure in the threads of the roping device

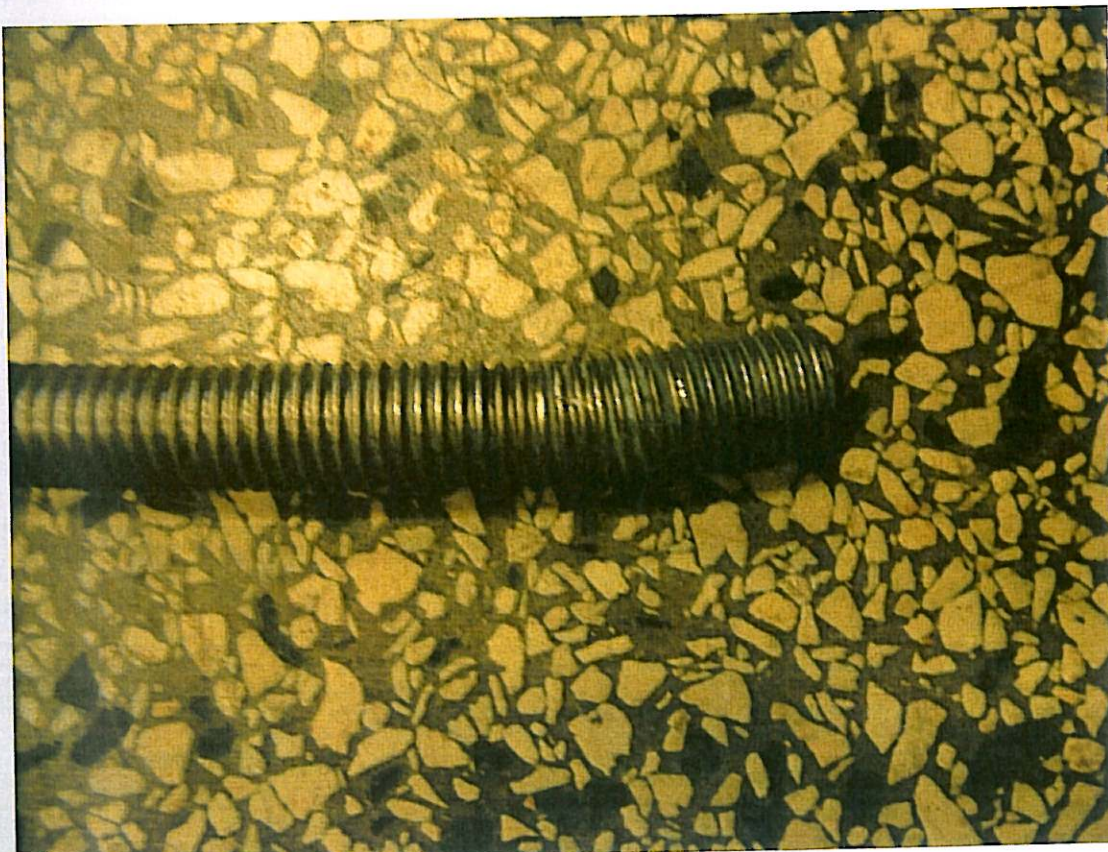
Fig. 6: Local bending of the threads due to deformation of the hollow section

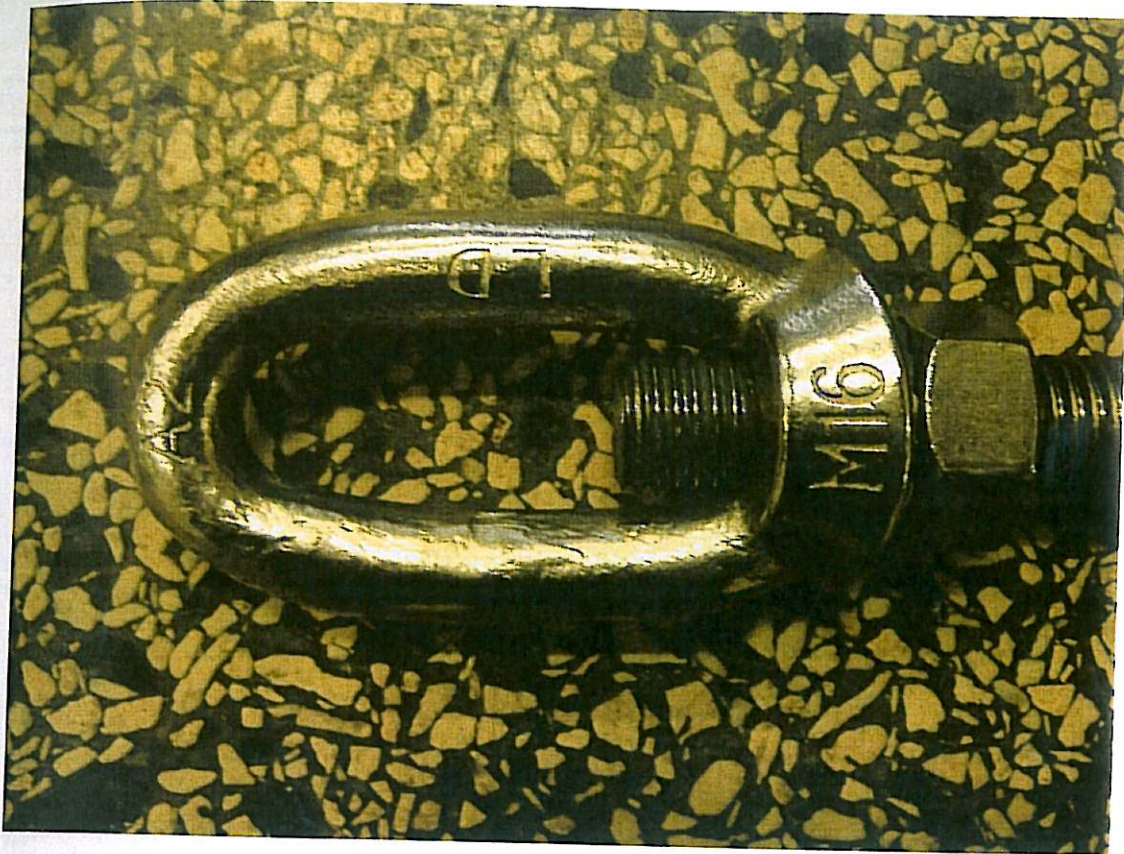
During the tests deformation of the eye-nut and the upper flange of the hollow section could be observed. The lower flange remained un-deformed.

Fig. 7: Deformation of the eye-nut

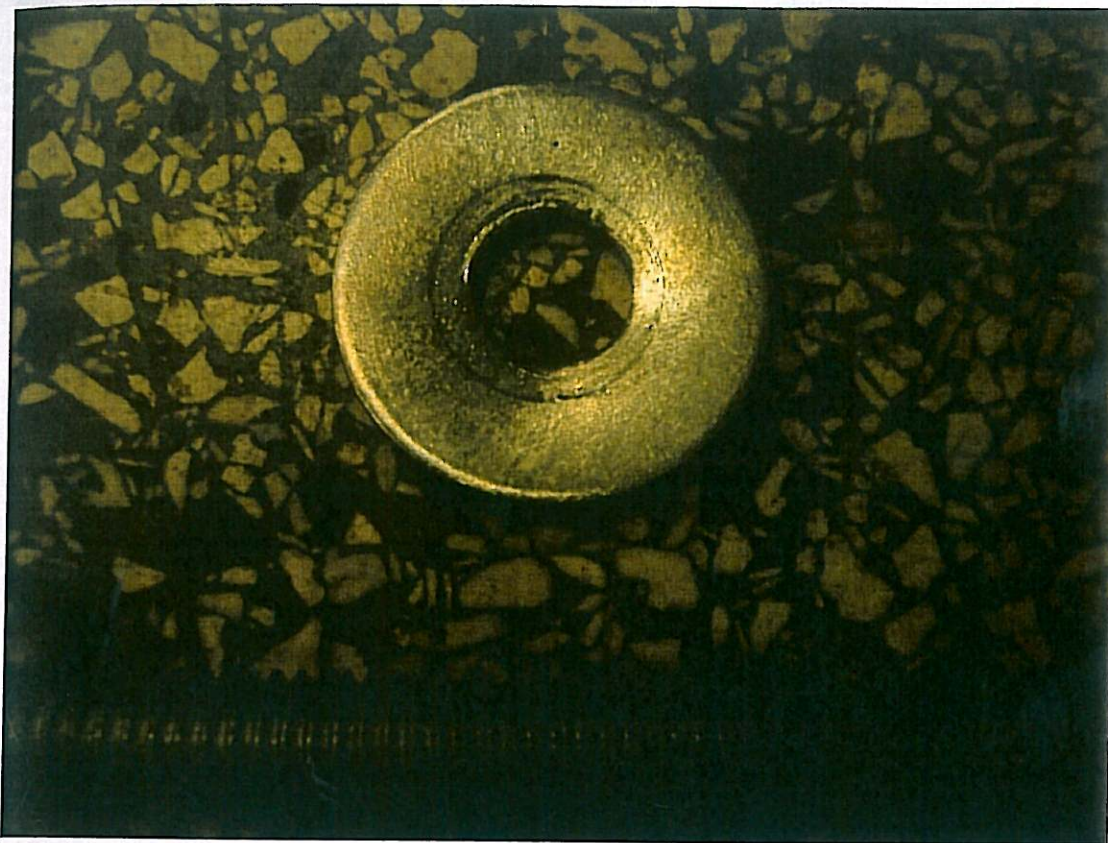
Fig. 8: Deformation of the washer

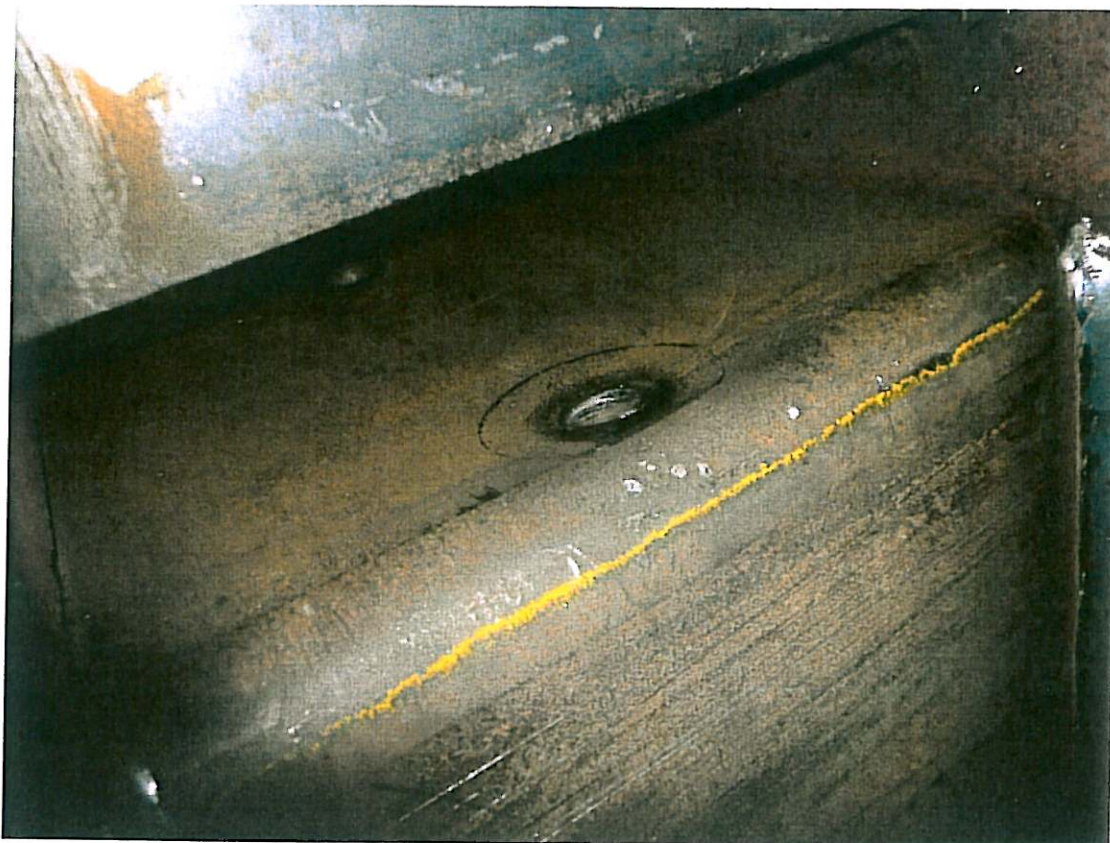
Fig. 9: Deformation of flange of the section

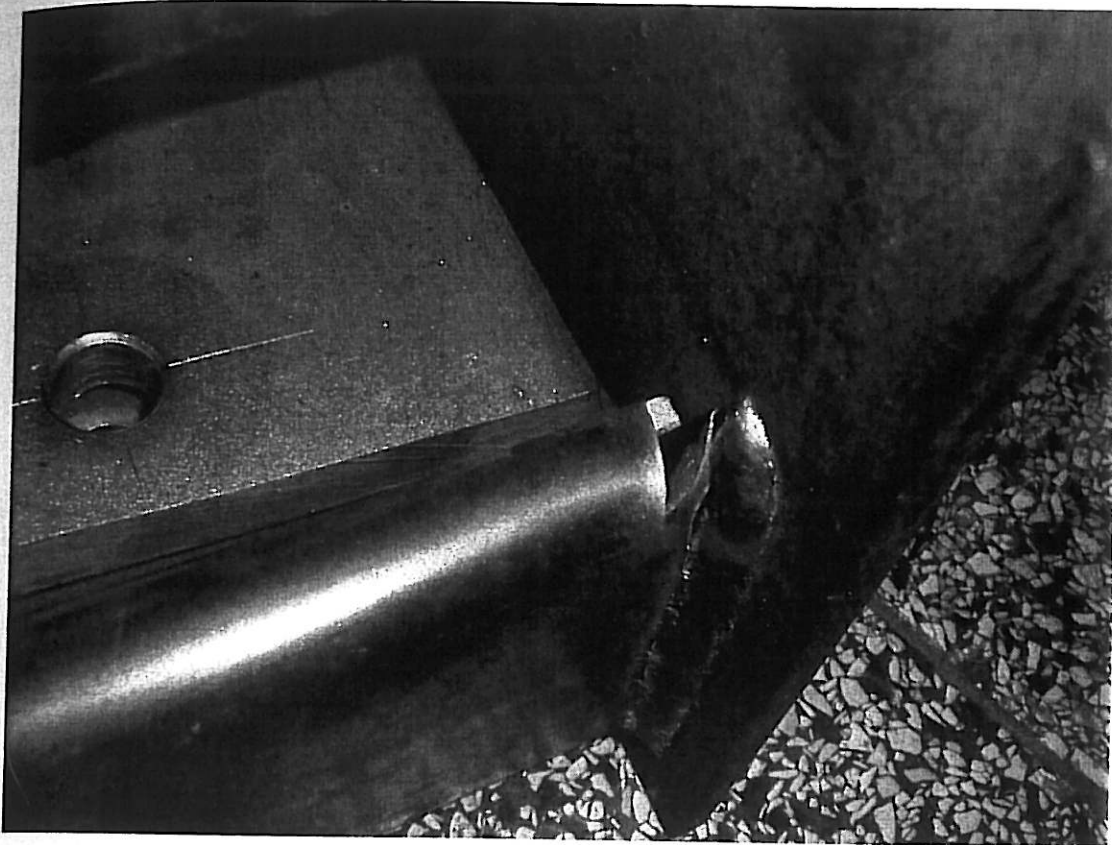
Fig. 10: Cracking of the section near to the welds

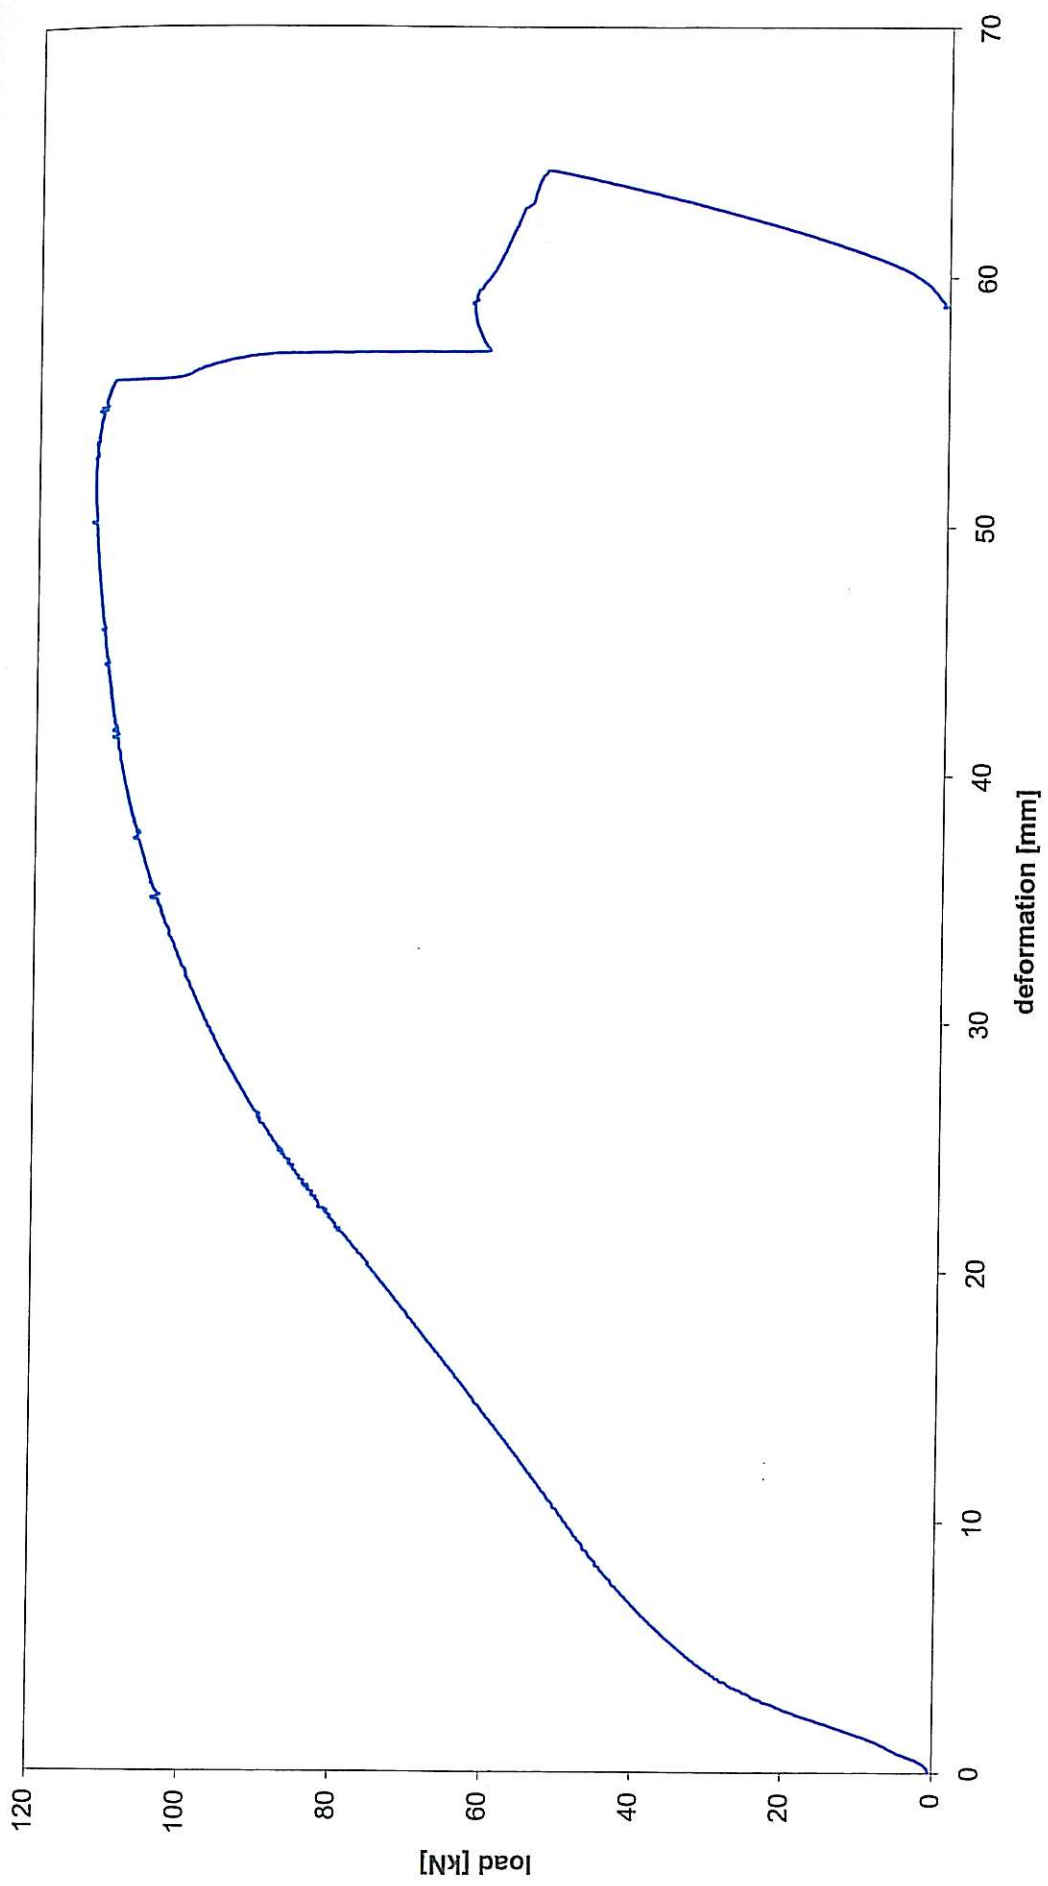
test No. 1

¹⁾ Bearing failure at load introduction
